EATON DAM (BULL RESERVOIR)
ERIE COUNTY, COMMONWEALTH OF PENNSYLVANIA
NDI No. PA 00016
PennDER No. 25-34

PHASE I INSPECTION REPORT
NATIONAL DAM INSPECTION PROGRAM

May 1979

Eaton Dam (Bull Reservoir), Erie County, Pennsylvania
NDI No. PA 00016, PennDER No. 25-34
Tributary to French Creek
Inspected 16 November 1978

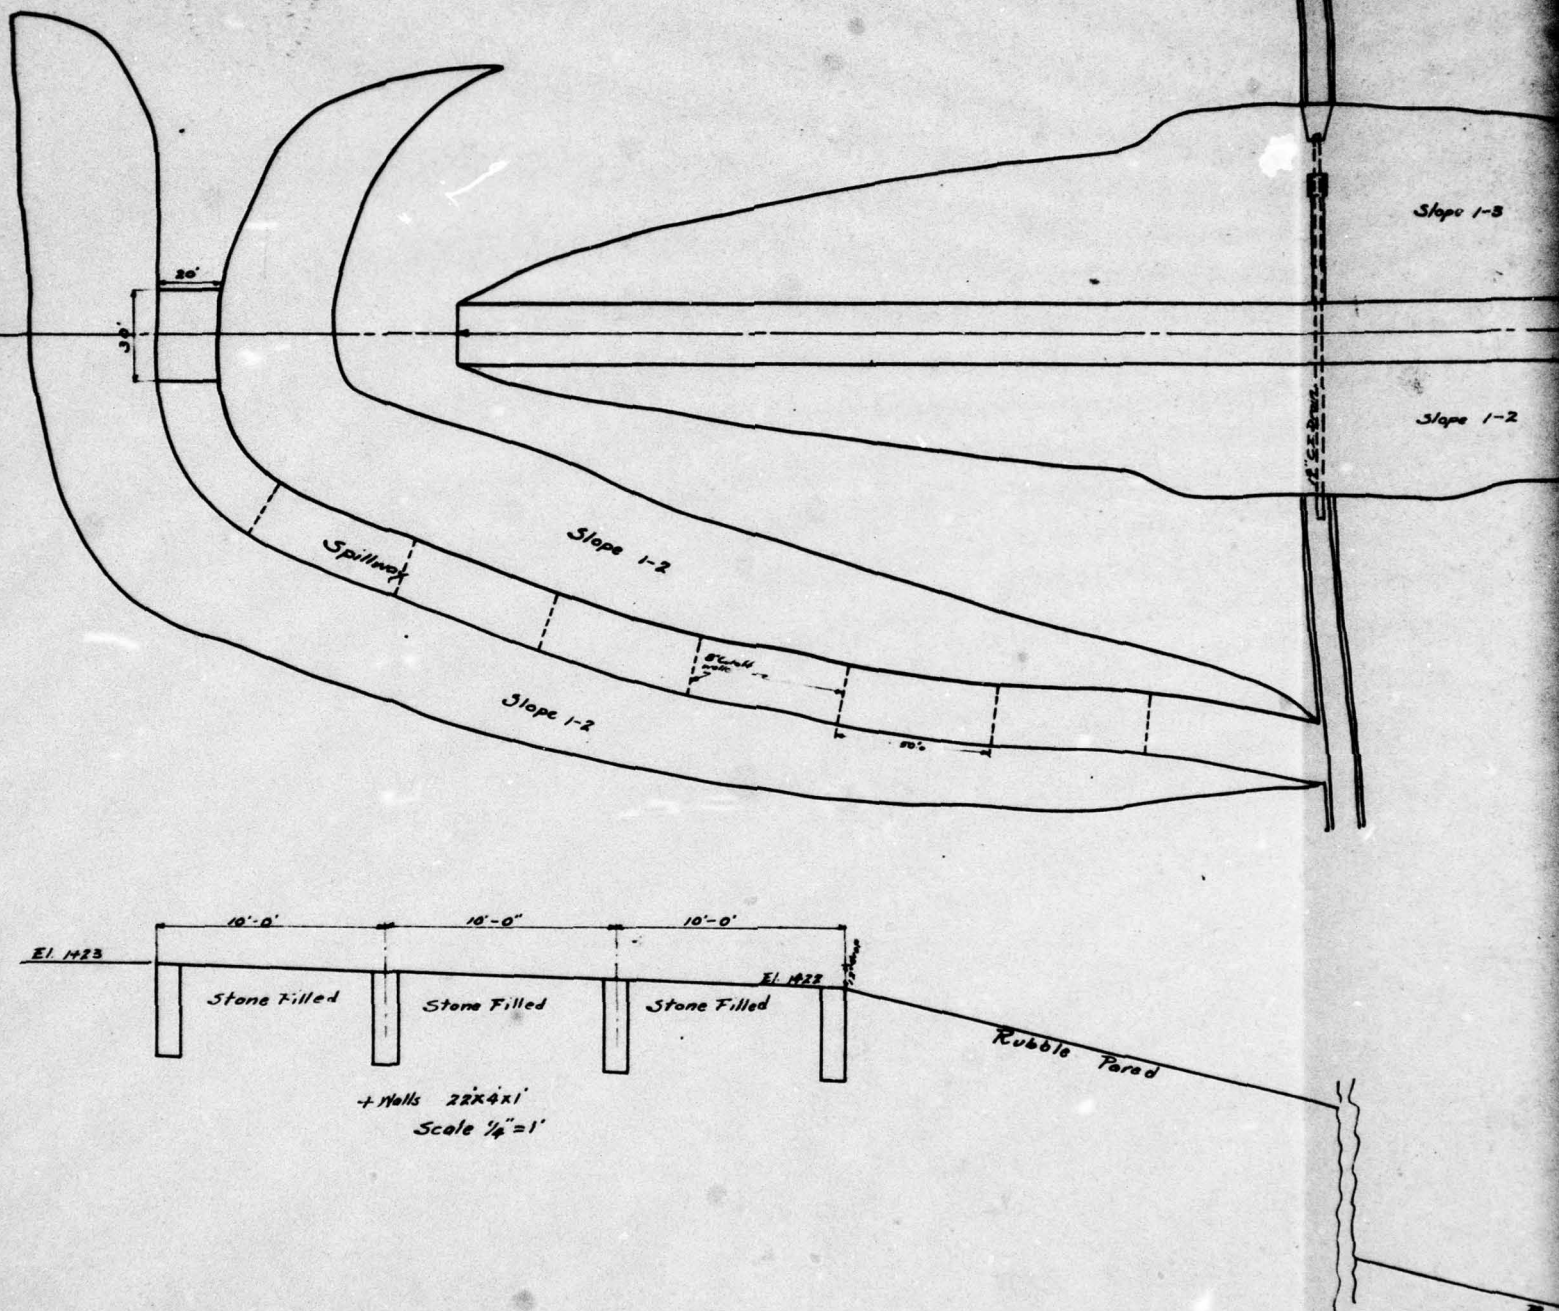
TOP VIEW OF DAM
Scale 1" = 30'

The design plans show a chute channel as the auxiliary spillway. However, the auxiliary spillway was not constructed according to the design plans. The auxiliary spillway as constructed consists of a 265-foot long trapezoidal approach channel and an 8-foot high concrete ogee weir (see Photos 5, 6 and 7). The outlet channel below the weir then carries the discharge from the reservoir to the natural streambed channel.

NOTE: This Design Drawing of the Auxiliary Spillway Is Not Representative of the "As Built" Conditions. See the Text of This Report and Photos 5, 6, and 7 For "As Built" Condition.

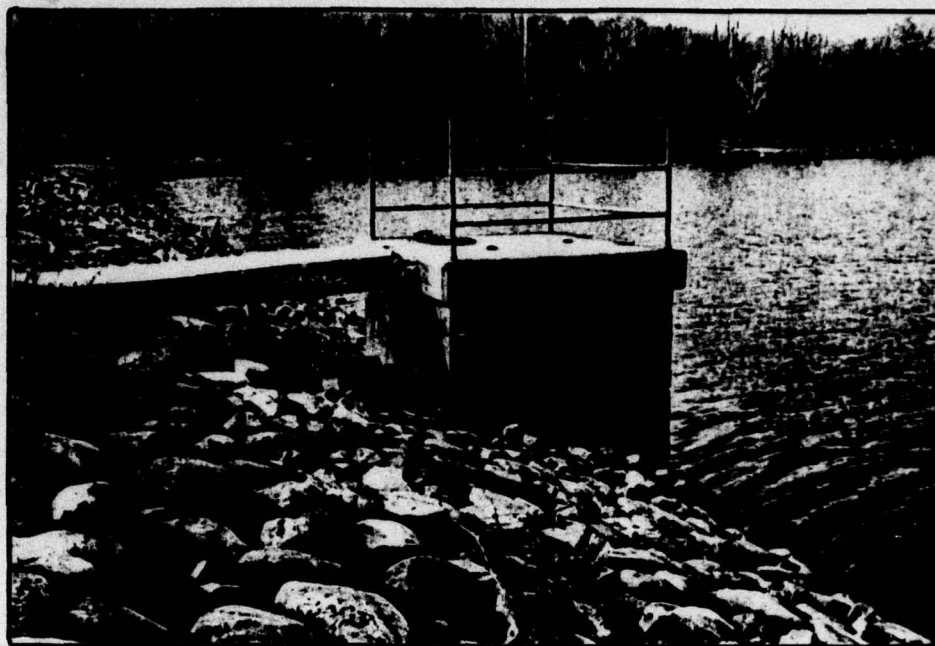
- c. Appurtenant Structures - The intake structure in the upstream embankment is cracked and spalled; consequently, reinforcing bars are exposed in some areas. The concrete in the auxiliary spillway also has signs of deterioration.

**PHOTO 1. Gate Valve Chamber in Upstream Embankment
(Note Spalling of Concrete and Exposed Reinforcing Bar)**

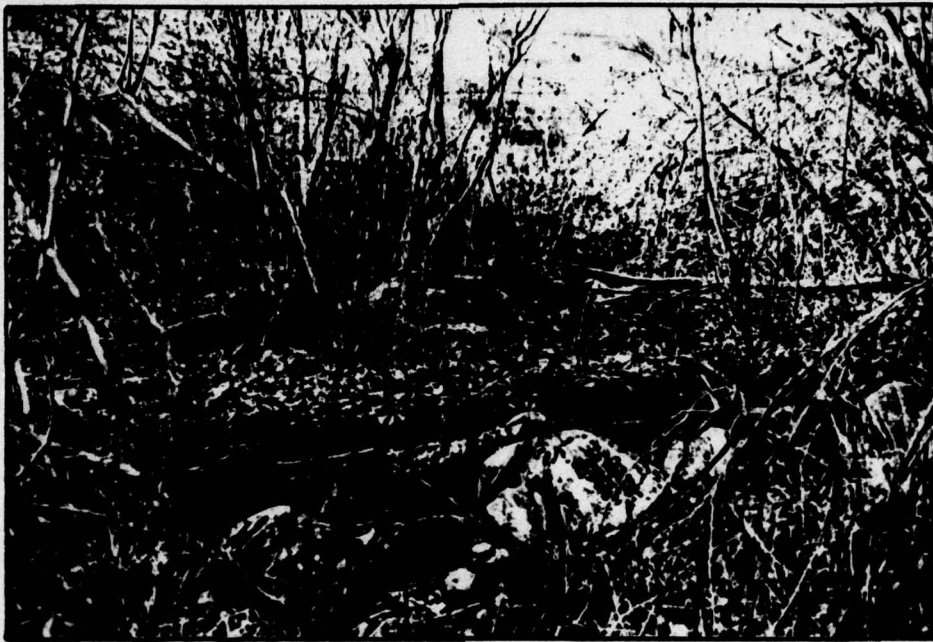
**PHOTO 7. View from Auxiliary Spillway Channel Looking Back toward Weir
(Note Brush and Debris in Channel)**
